IEPC-2002-030 Interactions within a Cluster of Low Power Hall Thrusters

International Electric Propulsion Conference
(Toulouse, France, 17-21 March 2003) (Deadline: 15 Jan)

Interactions within a Cluster of Low Power Hall Thrusters

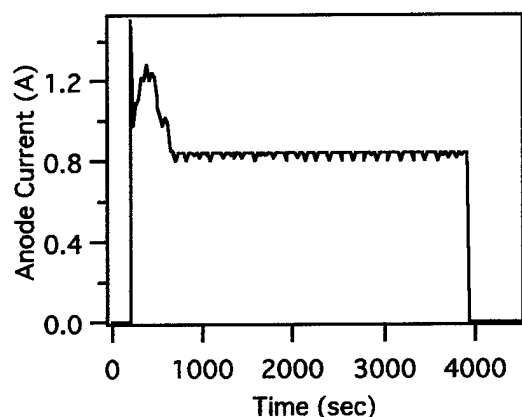
Fig. 2. Anode current trace characteristic of a start following exposure of the thruster to atmospheric conditions for several days. Duration of the anode current transient is 420 seconds. Note: initial current spike to 1.5 A is caused by start-up sequence.

Figure 2 shows a typical trace of the anode current during a start after the chamber has been open to atmosphere. The initial anode current spike (1.5 A) is due to the start procedure where the anode is current limited and the magnet is off. After the magnet current is switched to its nominal value, the transient consists of anode currents as much as 50% greater than the nominal value of 830 mA lasting approximately 300 to 500 seconds. The anode current transient only occurs for the first 300-500 seconds and does not return on start after the thruster has been conditioned. With subsequent exposure, the transient returns. Figure 3 shows that this behavior persists if the thruster anode discharge is cycled during the time period associated with the anomaly. Interestingly, the thrust level during the period of the anode current transient is unchanged. The 50% increase in anode current simply reduces the efficiency by a like amount.

The effect shown in Figs. 2 and 3 occurs under two distinct circumstances. First, it occurs when the chamber has been opened to atmosphere, exposing the thrusters to ambient air. Second, it occurs when the chamber pumps have been turned off, allowing the cryo-panels to regenerate, exposing the thrusters to a 0.5 Torr 'dirty' vacuum. In the latter case, the cryo-pump is valved off from the chamber, then it and the cryo-panels are allowed to warm to room temperature. The chamber pressure rises to approximately 0.5 Torr (N_2). The atmosphere within the chamber is assumed to consist of primarily xenon gas sublimated from the cryo-panels and water which was trapped by the panels during the initial pump down. However, molecular oxygen can be pumped by the cryo-panels at 25 K, so there may be substantial oxygen and nitrogen in the chamber as well [5]. The atmosphere within the chamber during this conditions will be sampled in future tests. Subsequent use of the chamber does not require repressurization to atmosphere. The chamber may be roughed to approximately 30 mTorr (N_2) at which time the cryo-pump and cryo-panels are activated.

The duration of the anomalous anode current transient appears to depend on the degree of exposure to the atmosphere, or gases sublimated from the pumping surfaces. If exposed to atmospheric conditions for several days, the anode current will return to the nominal 830 mA within 500 seconds. Subsequent exposures to the regenerated vacuum appear to reduce the length of the anode current transient by approximately 20%. For example, thruster 1 was started after exposure to atmosphere and the initial transient persisted for 425 seconds. The chamber was cycled without being opened to atmosphere and the subsequent current transient lasted 340 seconds. This chamber was again cycled without being opened and the anode current transient persisted for only 255 seconds. This trend is typical of all four thrusters in this study.

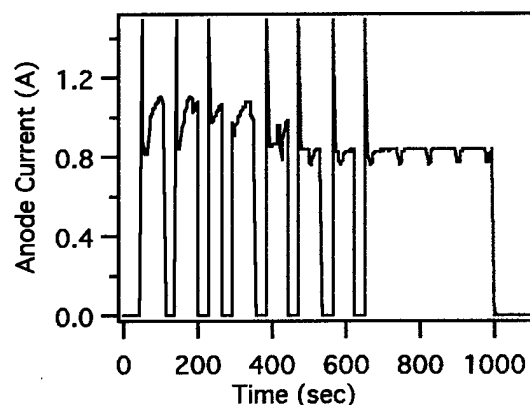
Fig. 3. Anode current trace of the transient with a number of nominally 60 second firings spaced 30 seconds apart. The anomaly persisted for approximately 4.25 min. Note that the thruster has been exposed to regenerated cryo-panel products for a period of 12 days and not exposed to atmosphere.

There are actually two effects shown in Figs. 2 and 3. The anode current transient is accompanied by a periodic (~60 sec) dip in the anode current. Figure 3 shows quite clearly that this period is not affected by the thruster on/off condition. This behavior has been correlated to the pressure fluctuations in the propellant lines of the thruster. The general effect has been documented previously [6]. Due to the low flow of propellant from the pressure bottle through the MFC, the bottle pressure regulator is opening causing a pressure increase in the lines between the regulator and the MFC. The valve on the regulator then closes until the pressure drops by some fraction of the set pressure and then the process repeats. The MFC responds to these periodic increases

in upstream pressure and overcompensates, reducing the flow rate. This overcompensation is due to the flow sensing element being upstream of the throttling valve in the MFC. The MFC does not recognize that it has over compensated and for approximately 3 seconds the flow is reduced by approximately 10%, reducing the anode current by a similar fraction. Efforts are underway to eliminate this issue.

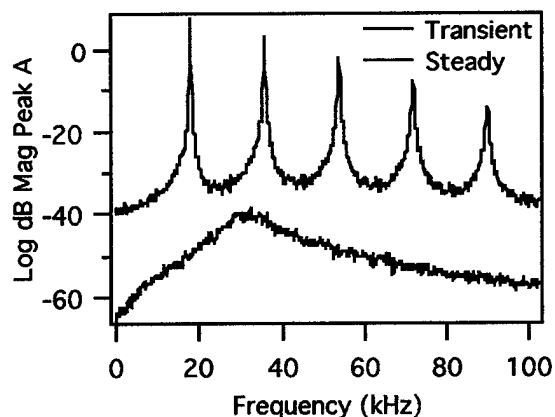
Fig. 4. Two spectra of current oscillations. The first during the transient with an average current of 1.14 A, and the second during steady state operation with an average current of 0.84 A.

The frequency of the anode current oscillations during a start were measured using Tektronix TCP202 current probes and an TEK1103 probe power supply connected to an Stanford Research Systems SR785 dynamic signal analyzer (DC-104 kHz). A plot of the oscillatory behavior during the anode current transient given in Fig. 4 and compared to the steady state behavior. During the period of anomalous anode current, we see a strong frequency response at approximately 18 kHz and what appear to be 4 harmonics. This behavior is radically different than the steady state behavior also shown in Fig. 4. In the steady state case, there is only a single broad peak at approximately 25 kHz. The steady state spectra is significantly less energetic with peak magnitudes approximately 20 dBA less than the transient case shown in Fig. 4.

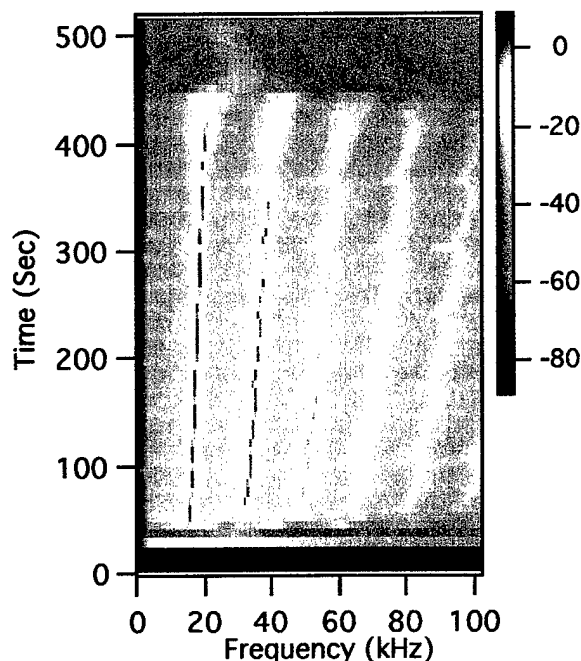
Fig. 5. Contour plot showing the time evolution of the anode Log Magnitude Peak Current (dBA) during a start where the anode current transient is present.

Figure 5 shows the time evolution of the anode current frequency spectrum. Although the frequencies of the major features are increasing slightly and the higher orders are decreasing in magnitude, these frequency components retain significant power until they collapse into the steady state single broad peak at 25 kHz. The periodic shifts in the peaks correspond to periods of lowered propellant flow during the pressure regulator approximately 60 second cycle.

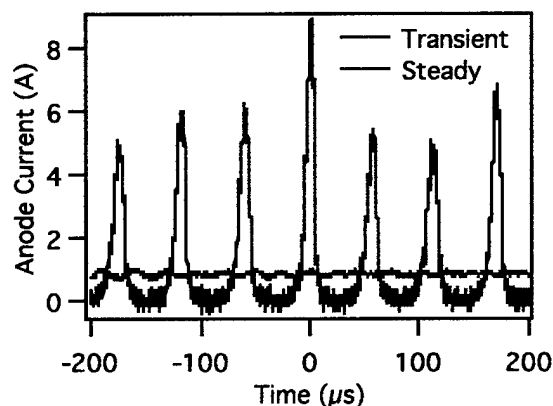
Fig. 6. Current oscillations of the transient and steady state cases seen in the time domain. Conditions are analogous to those in Fig. 4.

oscilloscope. Figure 6 shows the difference between the steady state behavior and the behavior during the anode current transient. During steady state, there is a strong DC anode current component overlaid by a weak 25 kHz component. The behavior during the anode current transient is nearly the opposite. The anode current is primarily AC with peaks measured as high as 9 A. In this mode of operation, the thruster is literally turning itself on and off every 50-60 μ s.

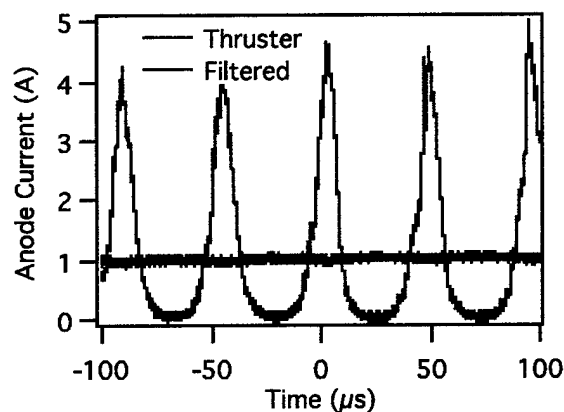
Fig. 7. Current oscillations during the anode current start transient as seen at the thruster and behind the filter at the power supply.

The effect of the LC filter is shown in Fig. 7 where we see the current measured at the thruster compared to the

current trace on the power supply side of the filter. The thruster anode sees 18 kHz on/off behavior, while the power supply does not see the oscillations. The LC circuit shields the power supplies exposure to the oscillations by 30 to 50 dB. The use of the LC circuit is not strictly necessary since the inherent impedance of the power supplies produces a similar filtering. Here, the filter is used to provide an additional degree of isolation.

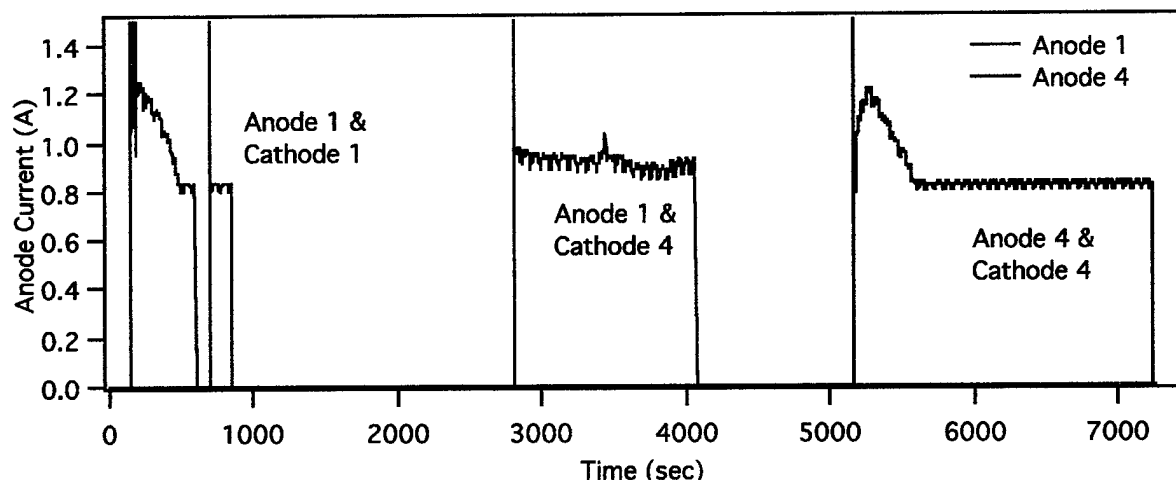
Fig. 8. Firing of anode 1 with cathode 1 and cathode 4 compared to the firing of anode 4 with cathode 4. Note that when anode 1 is fired with cathode 4, the coupling of the anode cathode is inferior to the nominal case, presumably since cathode 4 is not adjacent to anode 1.

As a result of the first three tests, the anode current transient had not been isolated to either the cathode or the anode; however, the effect did appear to require significant exposure time (hours) to manifest itself. The conclusive test was performed by taking advantage of the cluster of four Hall thrusters and their relative proximity within the vacuum facility. In this test, two unconditioned, adjacent thrusters, 1 and 4, were fired in the following sequence. First, thruster 1 was started using cathode 1, and fired for a sufficient time to condition the thruster. Then, the thruster was shut down and

restarted briefly to confirm its conditioning. At this time, cathode 4 (the cathode nominally attached to thruster 4) was substituted electrically for cathode 1. Anode 1 with cathode 4 was subsequently started. At this time, no anode current anomaly was detected. As a control, cathode 4 was electrically reconnected to anode 4 and fired. This resulted in a typical example of the anode anomalous behavior. The anode currents measured during this sequence are illustrated in Fig. 8.
